# A preliminary study of dynamic failures in laboratory tests

Qiyu Wang, Chengguo Zhang and Ismet Canbulat, A preliminary study of dynamic failures in laboratory tests, in Naj Aziz and Bob Kininmonth (eds.), Proceedings of the 17th Coal Operators' Conference, Mining Engineering, University of Wollongong, 8-10 February 2017, 283-295.

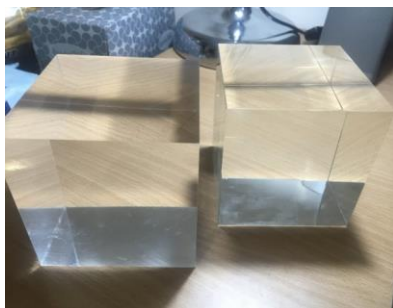
Two types of materials were tested in this project: Poly Methyl Methacrylate (PMMA) and K9 optical glass. PMMA is also known as acrylic based resin or Perspex. It is a thermoplastic of light weight and high transparency. It has a significantly high transmitting rate of visible light reaching 92% which is higher than normal glass. Currently, PMMA has been widely used as a substitute for transparent glass taking advantage of its high transparency and mechanical strength. K9 glass is a type of optical borosilicate crown glass manufactured in China. It is normally used in making the prism and optical lenses due to its low cost, high refractive index and high clarity. These two kinds of material are the only two materials that can be purchased from the market satisfying experimental requirements in terms of transparency, sample size, mechanical strength and cost. Semi-transparent materials are not considered in this project due to their influence on fracture observation. Figure 1 shows a comparison between the samples of PMMA (left) and K9 optical glass (right).

Figure 1: PMMA (left) and K9 glass (right)

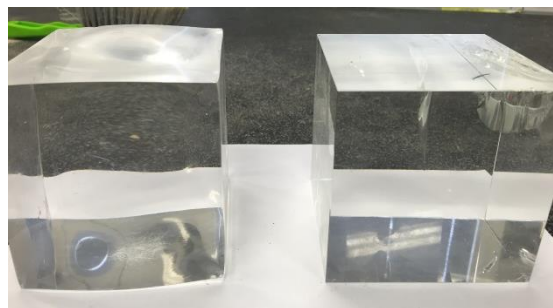
Under high levels of loading in a Uniaxial Compressive Strength (UCS) test, plastic deformation is observed for PMMA material in 100 mm size. K9 optical glass showed brittle characteristics that are similar to coal and consequently was chosen to be the material for this project. Figure 2 shows the PMMA sample (left) after a UCS test undertaken in the MTS rock testing machine.

Figure 2: PMMA after UCS test

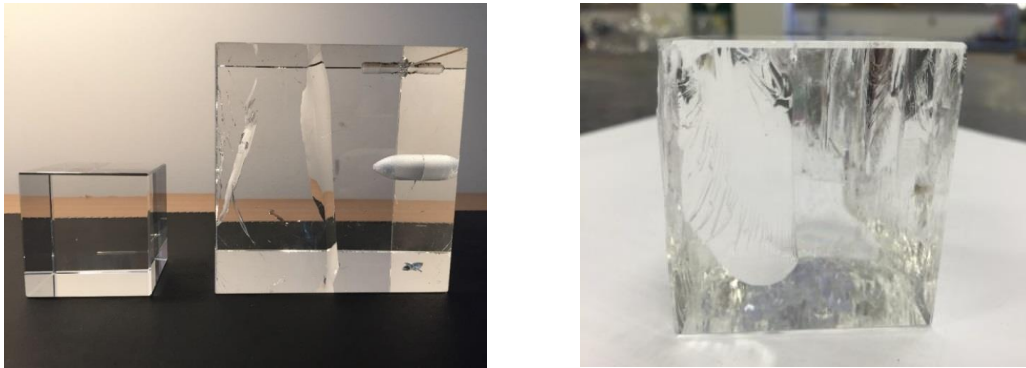
Two different sample sizes of K9 glass, namely 50 mm and 100 mm (in the shape of cubes as illustrated in Figure 3), were evaluated before the experiments. In the UCS test of 100 mm sample, the peak strength of the sample exceeded the limit of the hydraulic loading cell in the MTS testing machine. Therefore, 50mm samples were used in all experiments, which quadruple the stress at the same magnitude of loading.

Figure 4 illustrates the 50 mm sample after a UCS test.

**Figure 3: 50 mm sample (left) and 100 mm sample (right) Figure 4: 50 mm sample after UCS test**

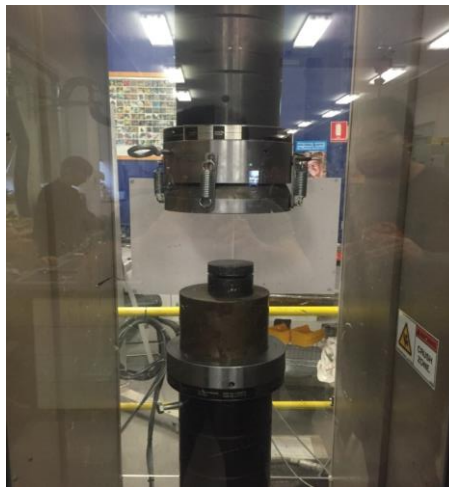
The UCS test is conducted using the MTS rock testing machine, as shown in Figure 5. A consistent loading rate of 0.1mm/s is used in all tests.

**Figure 5: MTS rock mechanics test system**

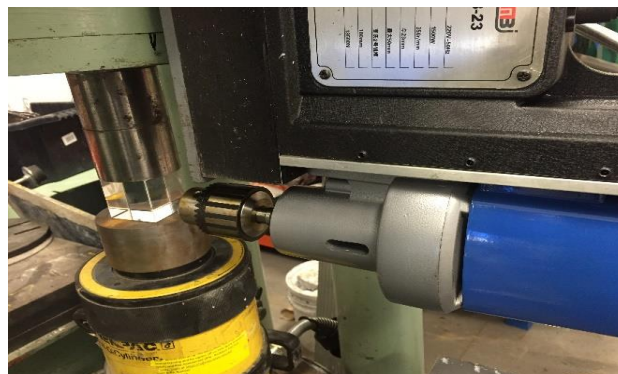
The drill used in the final test is illustrated in Figure 6. The magnetic drill is a specialised power tool used in the drilling of structural steel. It has a strong electromagnetic base enabling it to adhere to a steel surface. The magnetic drill offers increased stability and also provides better accuracy.

**Figure 6: Magnetic drill and hydraulic press**

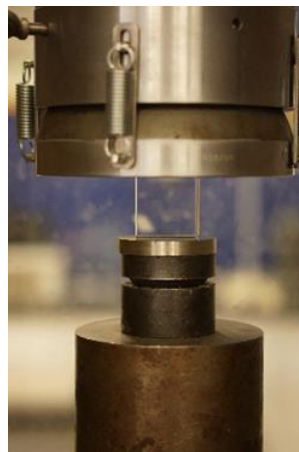
An intact optical glass sample was first tested to obtain its UCS value prior to drilling tests, as illustrated in Figure 7. In order to ensure the correct loading of the samples, a spherical-seat was used in these experiments as further preparation of samples was impossible. As indicated above, a consistent loading rate of 0.1 mm/s is used in the tests. The results from these tests are summarised in the following sections.

Figure 7: UCS test of intact sample

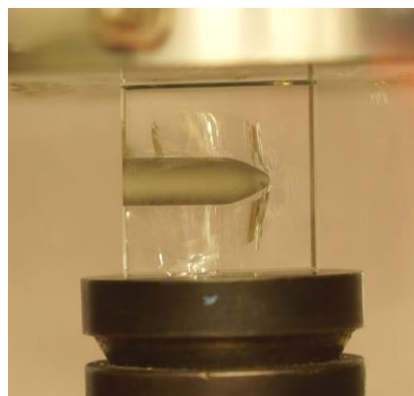
The second stage of testing was UCS testing of pre-drilled samples. The purpose of the second stage testing was (i) to observe the crack propagation around the borehole and (ii) to determine that the drilled samples fail before they reached the maximum capacity of the hydraulic pump that is used to provide the static loading of samples. The maximum capacity of the pump was 200 kN. The pre-drilled borehole is 12 mm in diameter and 40 mm long. Figure 8 illustrates a drilled 50mm sample in a UCS test.

Figure 8: UCS test of a drilled sample

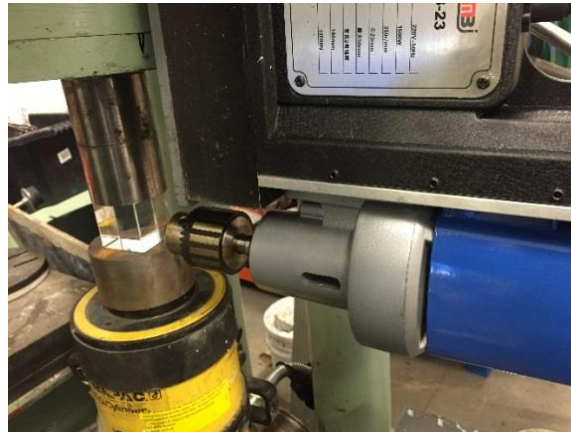
The tests were undertaken in two different testing frames. The first frame is for 50 mm samples and the second one is for 50 mm x100 mm rectangular samples. In the first frame (Figure 9), the magnetic drill is attached to top steel panel and the drill points to the sample centre. The samples are pre-loaded with different magnitudes of loads starting from 10 kN.

**Figure 9: Final test platform for 50 mm sample**

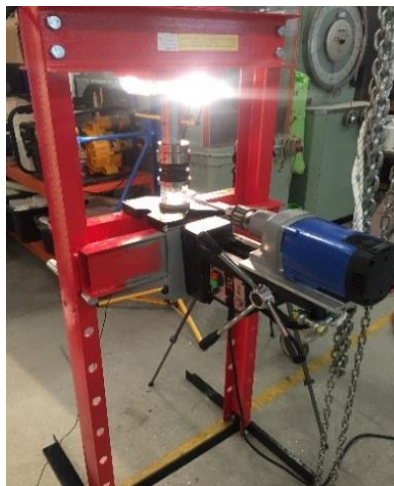
The second drill frame is shown in Figure 10. The reason for using a different frame is the location of the drill in relation to sample location. When longer samples were used in the first frame the drill bit did not target the middle of the samples; which resulted in imbalance loading of the samples during testing; therefore, the second frame was used for 50 mm x 100 mm rectangular samples.

**Figure 10: Final test platform for 100 mm sample**

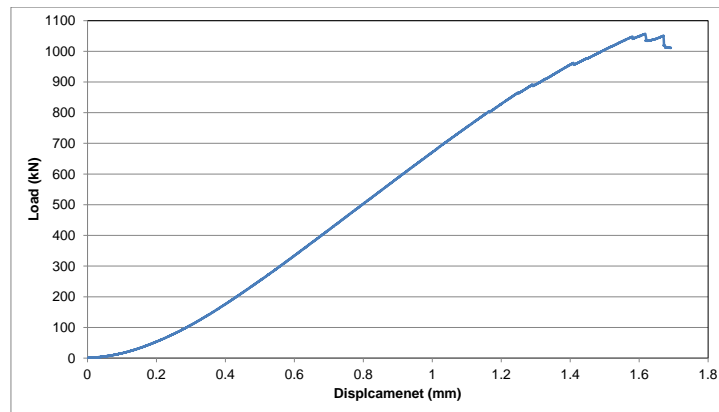
Figure 11 shows the load – displacement curve of a 50 mm sample during a UCS test. The graph indicates that the UCS of the sample is approximately 420 MPa. During the tests it was observed that once the sample reached its maximum strength (and the initial failure occurred) further loading of the sample was possible. However, due to safety reasons the tests were stopped once the samples were loaded up to the maximum strength. Therefore, no post-peak data is available from these tests. It is of note that the UCS of optical glass is not an appropriate parameter to predict cracking in this project as the glass starts to crack at a lower stress which is around 300 MPa.

**Figure 11: UCS test result of 50 mm sample**

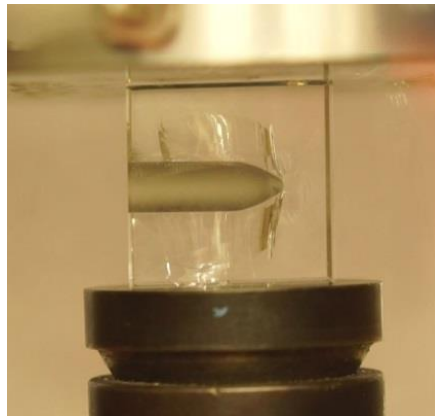
The samples used in this test are somewhat different from the intact sample tests presented above. Figure 12 shows a drilled 50 mm sample under loading of 100 kN. The graph indicates that the stress is concentrated around the borehole and leads to the initiation of cracking when the load is increased. As a result, the severity of cracking reveals the level of stress at a particular point.

**Figure 12: 50 mm sample under 100 kN loading**

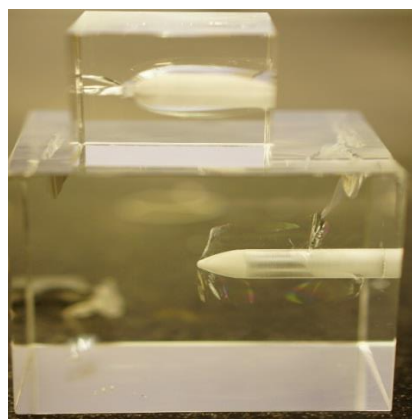
Figure 13 illustrates a comparison of 50 mm and 100 mm drilled samples. The drill depths of each sample are 40 mm and 50 mm respectively. The 100 mm sample starts to fracture at a much higher stress during the UCS test which exceeds the limit of hydraulic press and consequently, 50 mm is chosen to be the size of test sample for the final tests.

**Figure 13: 50 mm and 100 mm sample**

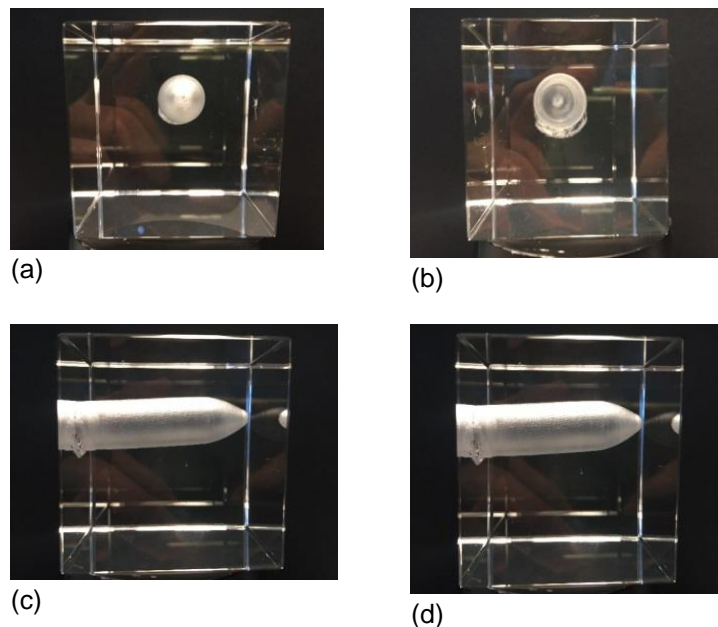
Figure 14 illustrates the test results under 10 kN loading. As clearly shown in the figure, there is no sign of failure, despite the drill reaching the end of the sample. Less than 10 kN loading, the stress on the testing sample is equal to approximately 4 MPa, which is much smaller than the maximum UCS of 420 MPa. This test result indicates the fact that drilling itself will not cause a dynamic failure or fracturing of the sample.

**Figure 14: Test result under 10 kN in (a) front view (b) back view (c) side view (d) top view**

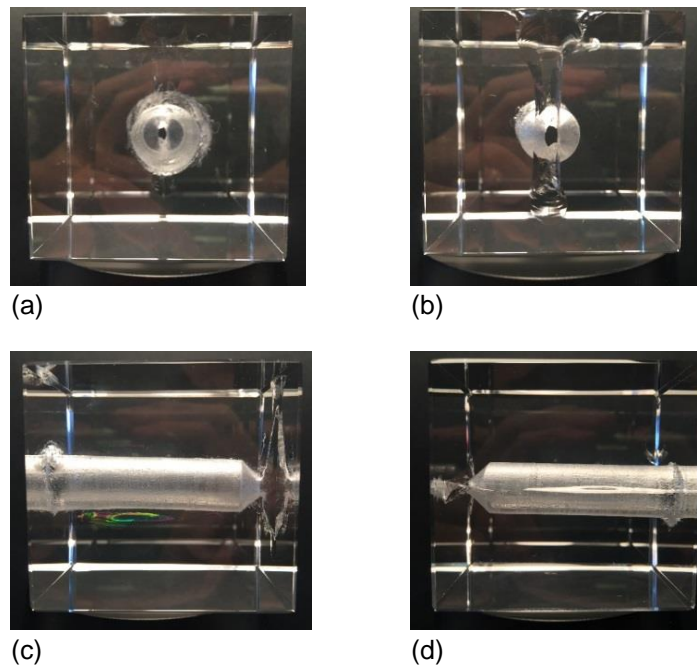
Figure 15 illustrates the test result under 40 kN loading. Different from the 10 kN loading, it can be seen from Figure 15(b) that extra damage has occurred to the sample when the sample is drilled through along the direction of loading. However, this cannot be classified as burst because of the gradual failure process during drilling as reviewed in the video.

**Figure 15: Test result under 40 kN in (a) front view (b) back view (c) side view (d) top view**

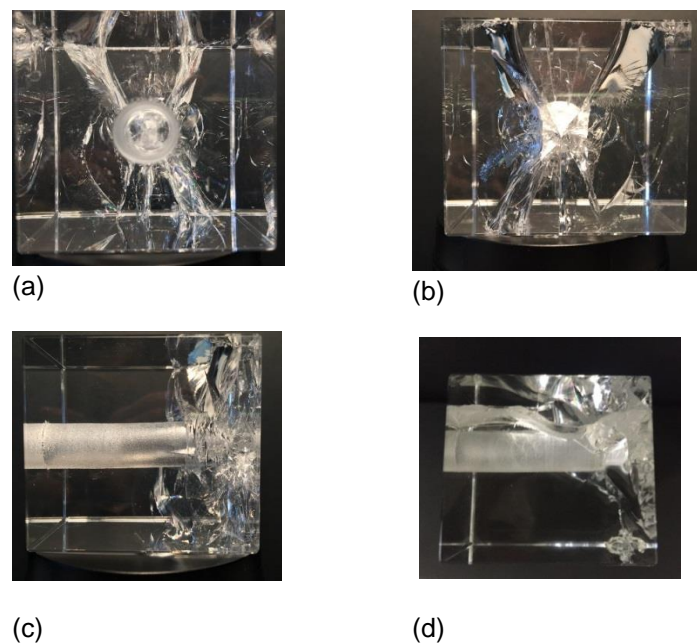
Figure 16 illustrates the test result under 70kN of static loading. Under the 70kN loading, dynamic failure occurs before the drill reaches the end of a sample. As can be seen from Figure 16(b), the cracks caused by dynamic failure concentrated around the top of the borehole and radiate out along the direction of uniaxial loading. As is also evident in Figure 16(c) there was no crack around the borehole until dynamic failure occurred.

**Figure 16: Test result under 70 kN in (a) front view (b) back view (c) side view (d) top view**

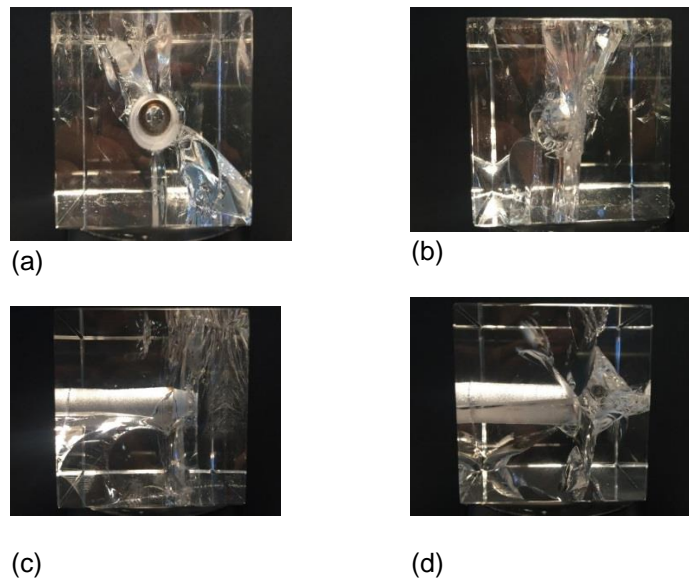
Figure 17 illustrates the test result under 130 kN of static loading. Dynamic failure occurs before drill bit reaches the end of sample and the position is shown in Figure 17(c). Under a higher magnitude of loading, unlike the 70 kN test, the sample starts to crack around the drill hole during drilling as shown in Figure 17(c). This failure somewhat reduces the intensity of the dynamic failure.

Figure 17: Test result under 130 kN in (a) front view (b) back view (c) side view (d) top view

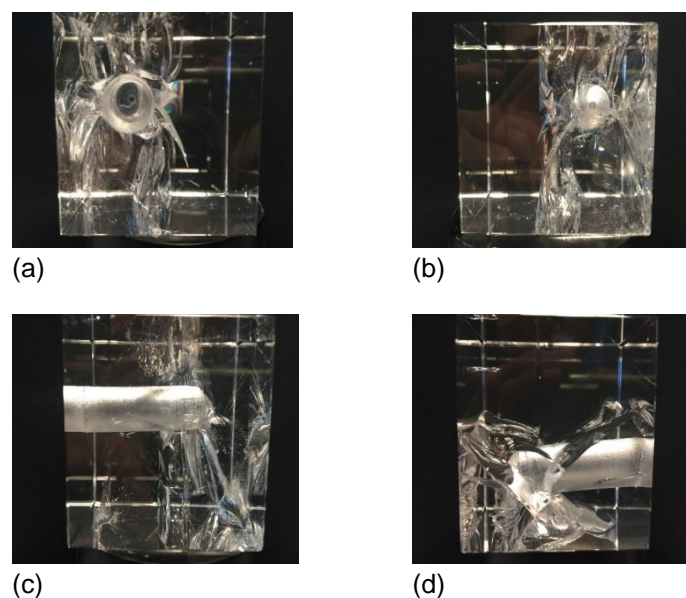
Figure 18 illustrates the test result under 160 kN of loading. In this experiment dynamic failure occurred as the drilling started and reached the maximum intensity when the drill bit was approximately half way through the sample, which is earlier than the other loading cases.

Figure 18: Test result under 130 kN in (a) front view (b) back view (c) side view (d) top view

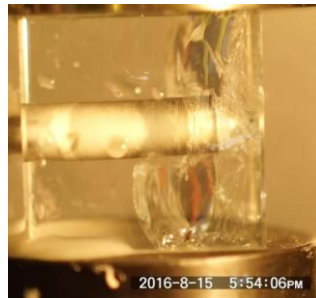
Figure 21 is the screenshot of the same test sample at the moment of dynamic failure. It can be seen that the time shown on both figures is identical, which indicates that the dynamic failure occurred in less than 0.02 seconds (recording rate of 50 frames per second).

**Figure 21: Test sample bursting under 70 kN loading**

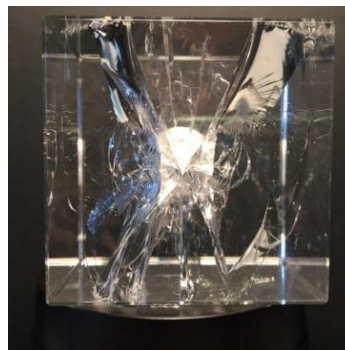
Figure 22 is the back view of the test sample under 70 kN loading. It can be seen from this figure that the fracturing is concentrated around the centre of drill hole and radiates out. The level of concentration is highest at the end of the borehole and reduces when propagating.

**Figure 22: Back view of test sample under 70 kN loading**

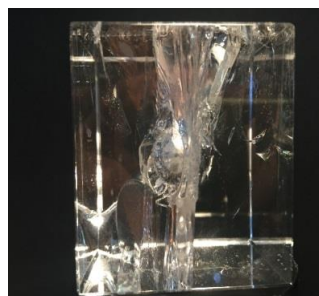
Figure 23 shows the back view of test sample under 130 kN loading. From these two figures it is evident that fracturing occurs along the vertical direction and there is no fracturing along the horizontal direction. The main reason for this pattern is the major principal stress. The sample fractures along the direction of loading and release the strain energy in that direction. As a result, all samples have a fracturing pattern along the vertical direction.

**Figure 23: Back view of test sample under 130 kN loading.**

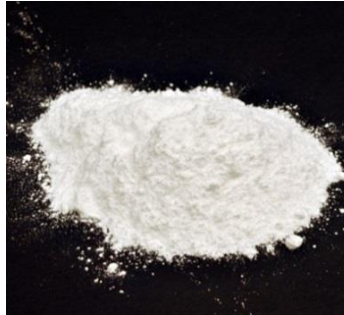
The drill cuttings of the optical glass without any loading are shown in Figure 24. These cuttings are collected during the drilling process for UCS test preparation. It is evident that the cuttings are mostly powdery fine particles.

**Figure 24: Drilling cuttings without loading**

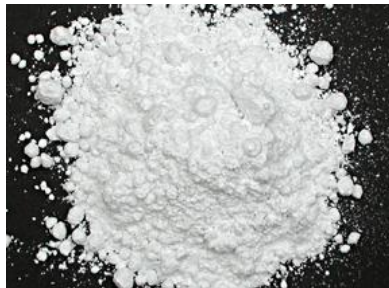
Figure 25 illustrates the drill cuttings collected after the 70 kN pre-loading test. From these two figures it is evident that the cuttings become blocky in the pre-loading tests. These blocky cuttings are mainly formed for two reasons:

- The glass powders agglomerate and form a small block due to the water for dust suppression during the test.
- The glass powders cover glass fragments and then agglomerate to form a small block

**Figure 25: Drilling cuttings after pre-loading test**
